## THIS PRARIE IS NO DOG - Continued

In Gazette issue No: 11, Volume 15, May 2004, I wrote about my experiences building the Mitchell 45xx 2-6-2. The engine was sold on through an intermediary and so I did not know to whom it ultimately went.

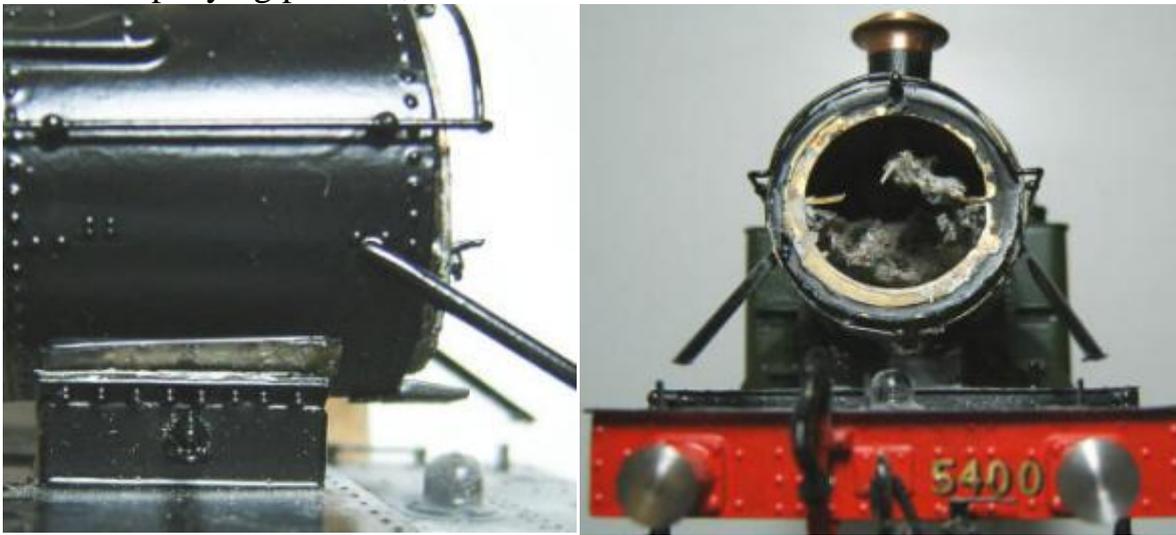
However, I thought readers might be interested in what happened to it. In the late summer of last year, I received a letter from the owner in Scotland, via a convoluted chain of Guild officers, with alarming news. The smoke box appeared to have exploded and lifted from the footplate. I took delivery of the engine at Bo'ness while on a trip there soon after and brought it back to my workshop. As you can see from the accompanying pictures, it looked horrendous.

The ballast, which had been fitted in the smoke box, was a mixture of liquid lead and dilute PVA. Following my questions on the 7mm E-group, there was a considerable exchange of ideas and news of several instances of other people's stock suffering a similar fate. It seems fairly certain now that the ascetic acid in the PVA has reacted with the lead, or something in the lead, and the resulting corrosion has swelled it to the stage where the smoke box has burst and lifted off the saddle, pushed the door off and lifted the boiler away from the tank ends. The sharp eyed among you will have noticed that the buffer plank number is wrong it should be 4500. Strange, no one noticed in four years.

Fortunately, all the parts, save for the smoke box door, turned out to be salvageable but the paint job I had spent so much time and effort on would have to go. It was only the second engine I had ever painted, which made it all the more galling. Stripping took two separate coats of Nitromoors and a wash in cellulose thinners but even that did not get all of it off. Obviously a good paint job!

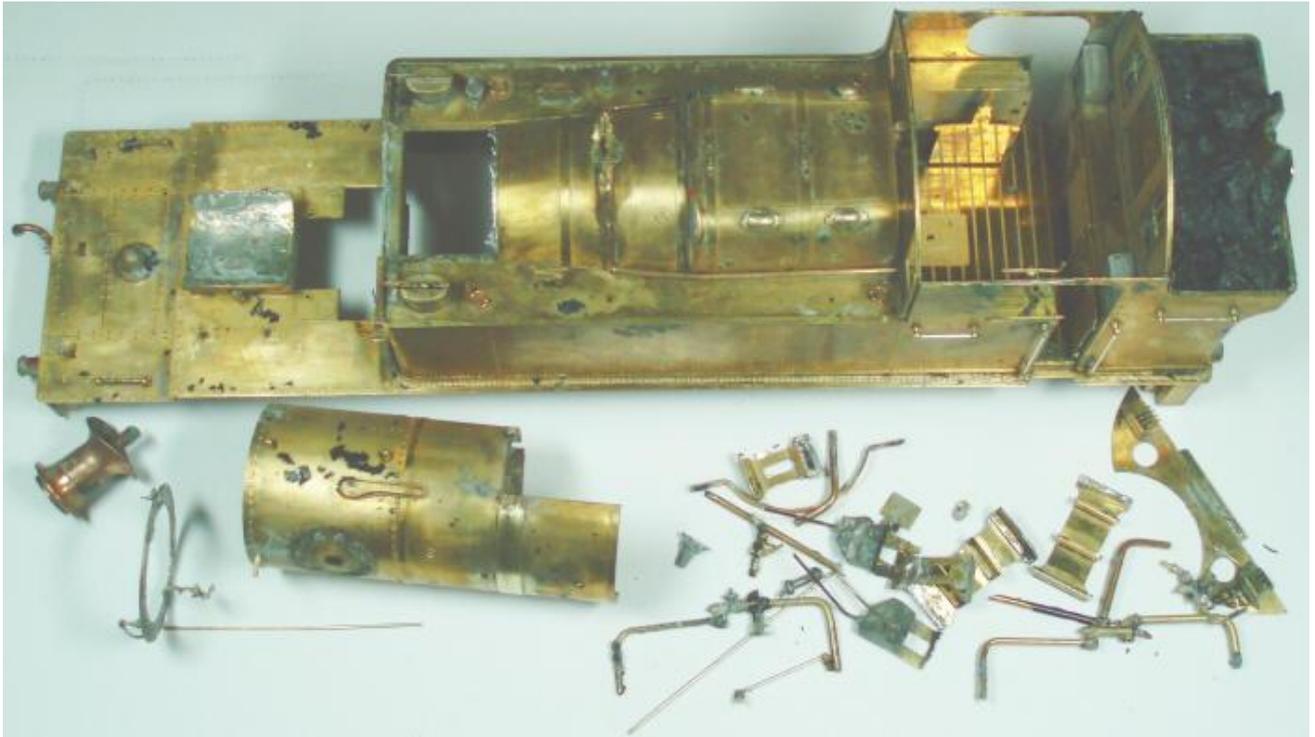
Here you can see the damaged parts that were removed prior to cleaning up.

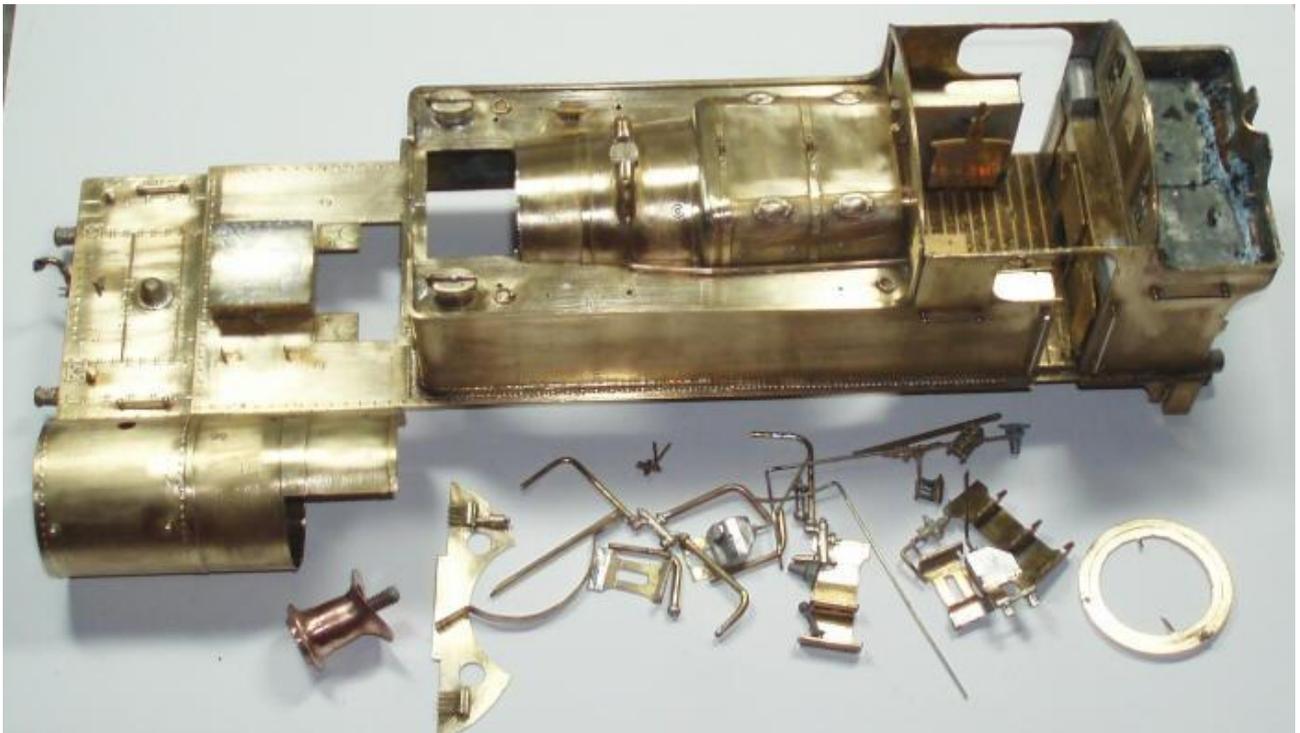
Cleaning out the corroded ballast from the smoke box took a while, as did preparing all the parts ready to be soldered back. Rebuilding in reality took less time than getting the parts ready but you can see from the pictures how it progressed.

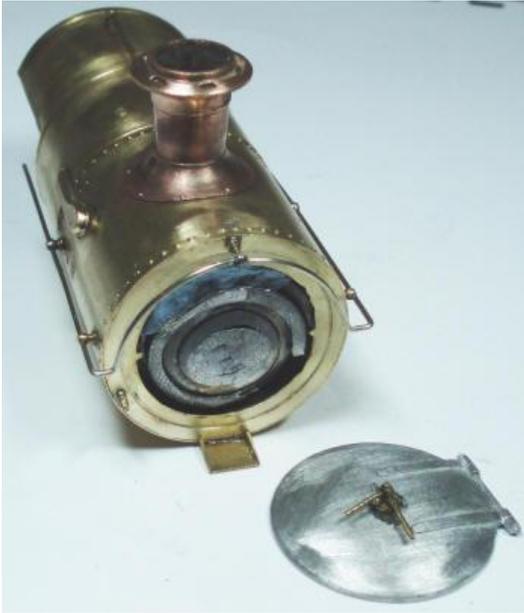
Here is the rebuilt smoke box fitted with half a pound of rolled lead and fixed in with blue-tack. I was taking no chances with it this time however, it has been suggested by (I think) Bob Alderman, that liquid lead and a resin based powered glue is non-reactive.

The door is new since the original was damaged beyond repair. The lamp iron to replace the one on top of the smoke box that was damaged in the clean-up process came from the spares box. It was a lost wax casting left over from a DJH kit. However, had the box failed to come up trumps it would not have been difficult to fabricate a new one. Here is the almost completed repair waiting

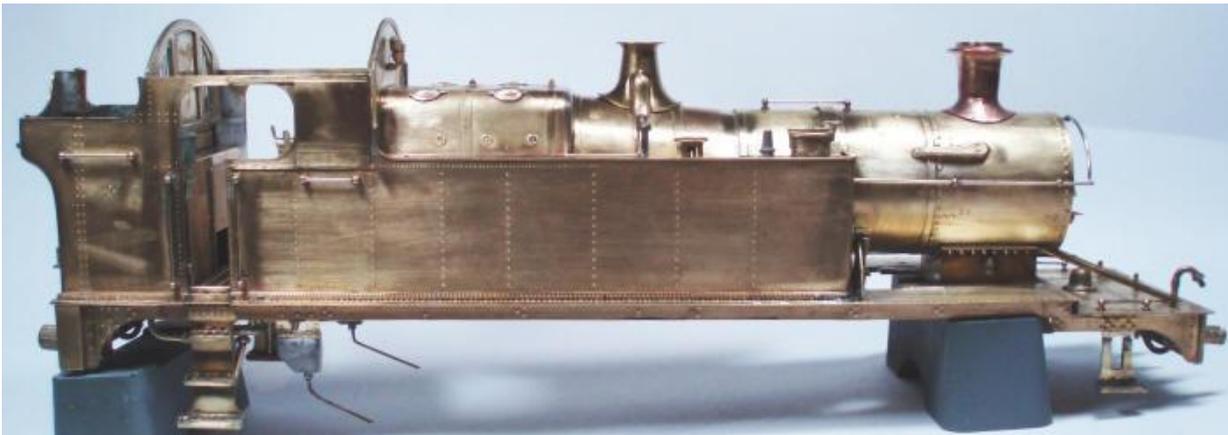
to go to the paint shop. At the time photographing, the lamp iron still had not been fitted.

The front steps were a particular problem, they are flimsy on the original, and they fractured at a bend line during deconstruction and so had to be held together with bits of scrap brass. Not easy to solder up as the parts were all tiny and close together, but once more proving the utility of an RSU, steel plate and magnets, I doubt I could have done it with just an iron.

I also took the opportunity to correct the front stays and fit them in their proper place. Another error neither I, nor anyone else, had spotted until I came to take it apart for repair. The safety valve cover remains loose fitted inside its mounting with blue-tack so that it can be removed for polishing.

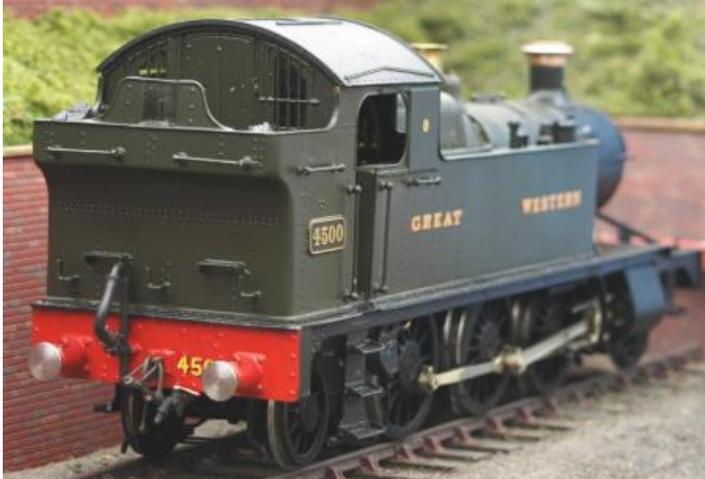
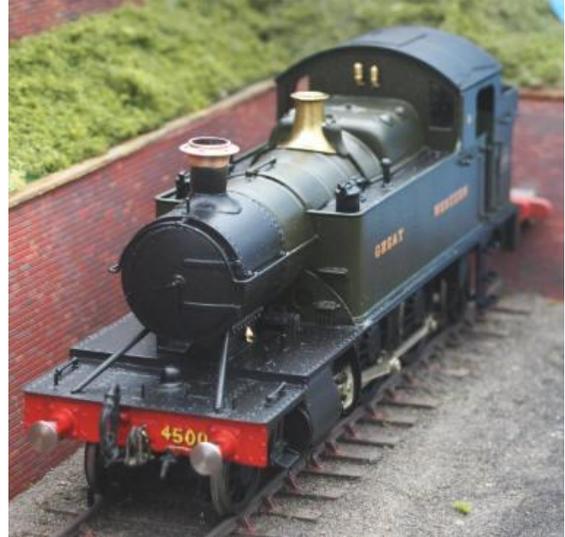
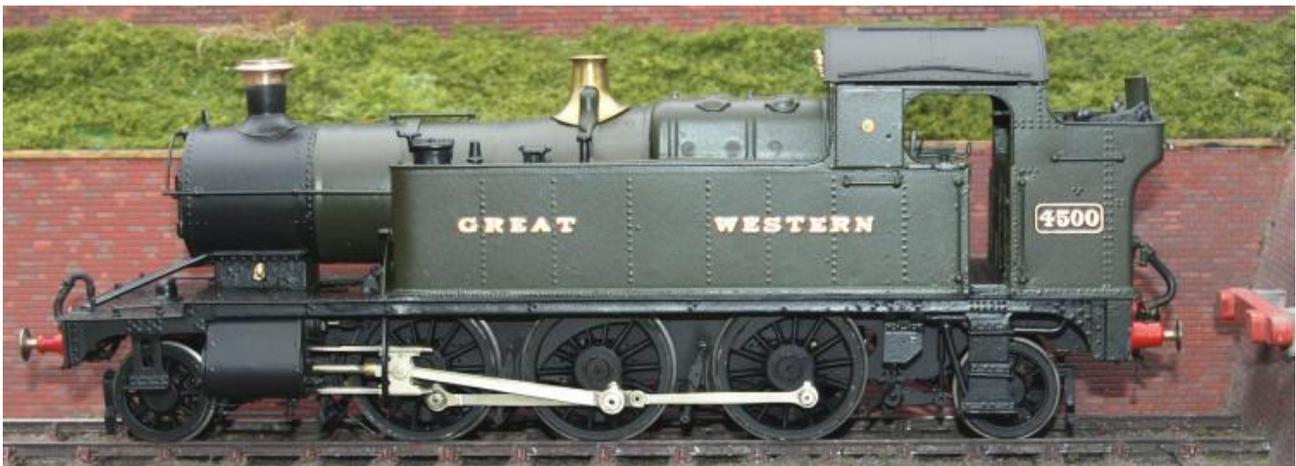
Here is the newly painted engine back from Dennis Morley's ministrations parked in my private siding until we can arrange delivery to its owner. I fancy it looks better now that it did originally and a couple of small errors have been corrected too.

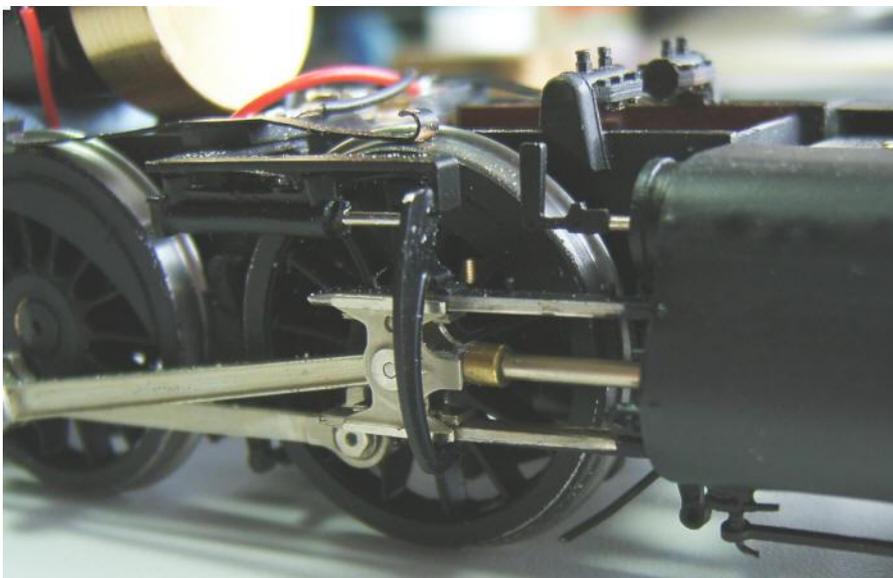
including this shot of the slide bars, as I did not have a digital camera when it was built. It does illustrate how beautifully the kit is designed.
